Title THE UNITED STATES
STRATEGIC BOMBING SURVEY #92

THE EFFECTS
OF
THE ATOMIC BOMB
ON
HIROSHIMA, JAPAN

Physical Damage Division

May 1947
PLEASE RETURN PROMPTLY TO
ROOM 326

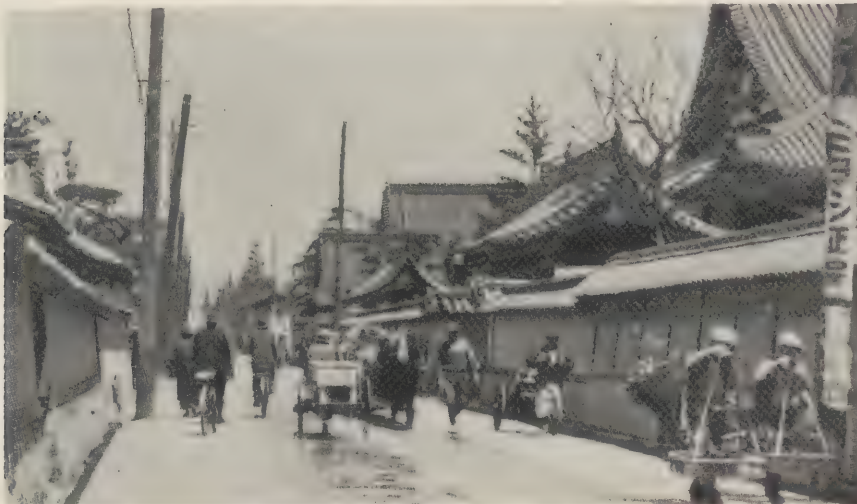
PHOTO 4-IV. Looking north-northeast along Tera-machi, the Street of Temples. This road is considerably wider than most roads found in residential areas. This district was completely ruined.

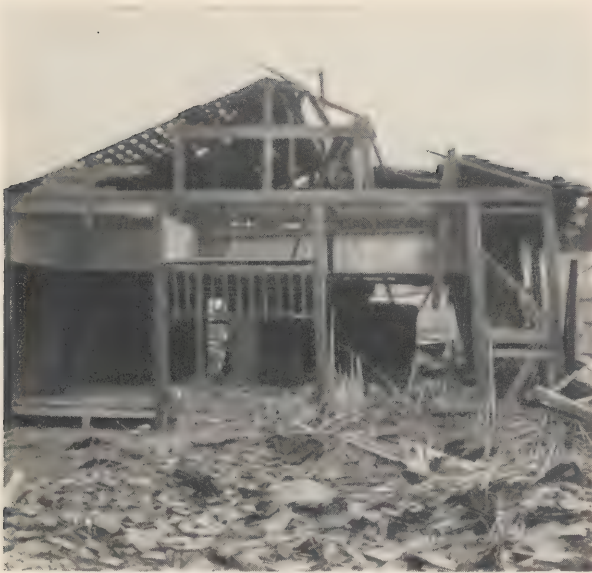
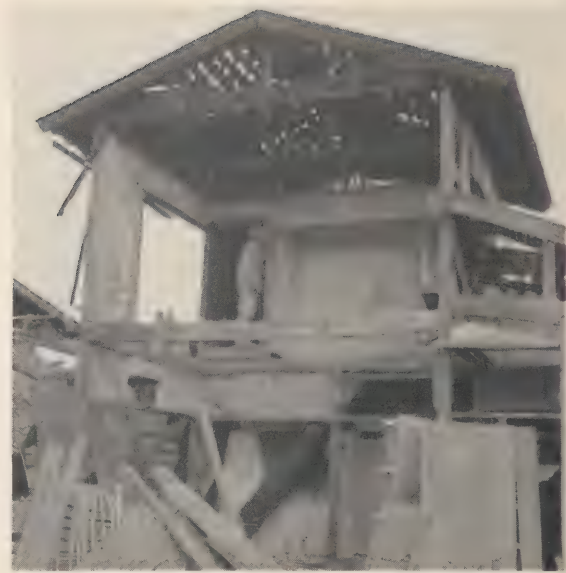
PHOTOS 20-VIII and 21-VIII. These photos show exterior views of damaged dwellings which show the typical framing of this type of building. Note the simple roof system, the lack of diagonal and lateral bracing, and the extensive use of unsawn lumber.

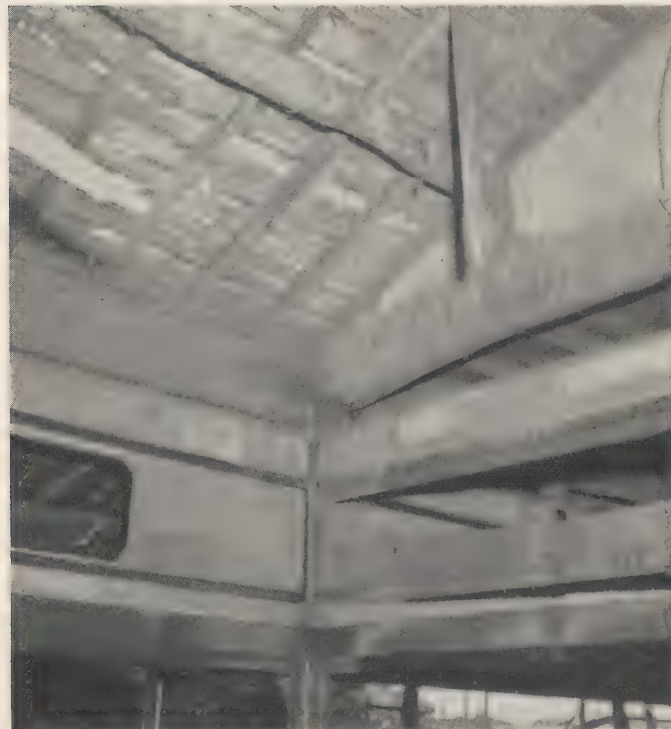
PHOTO 22-VIII. This shows the interior framing details of the same type of building described above.

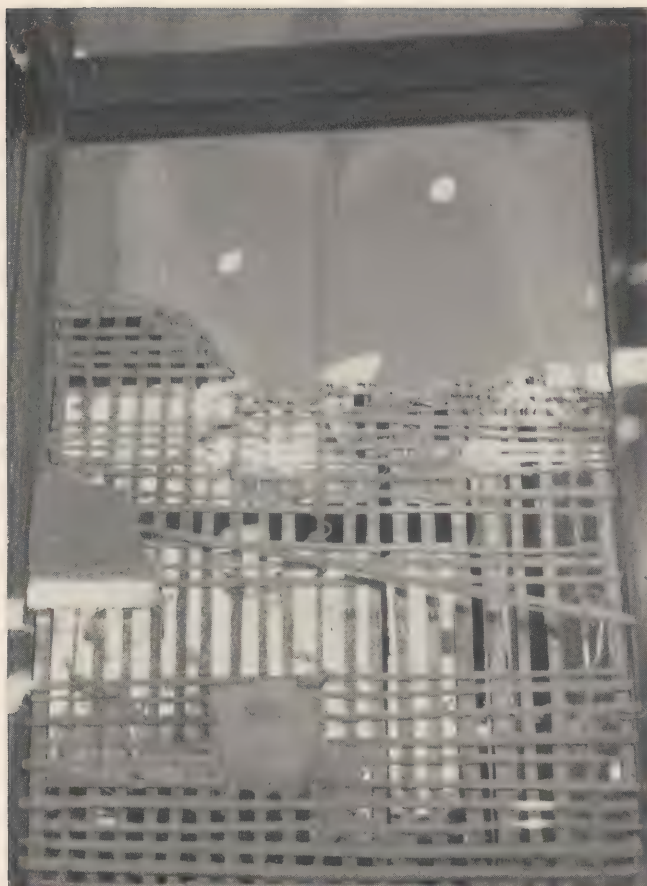
PHOTO 23-VIII. Damage to this typical wall panel has broken away the plaster and exposed the bamboo lath.
